DOC NO. 150-040073

## Service Bulletin WSB-002

### MODIFICATION OF AN RT-138 GUARD RECEIVER TO IMPROVE SPURIOUS PERFORMANCE

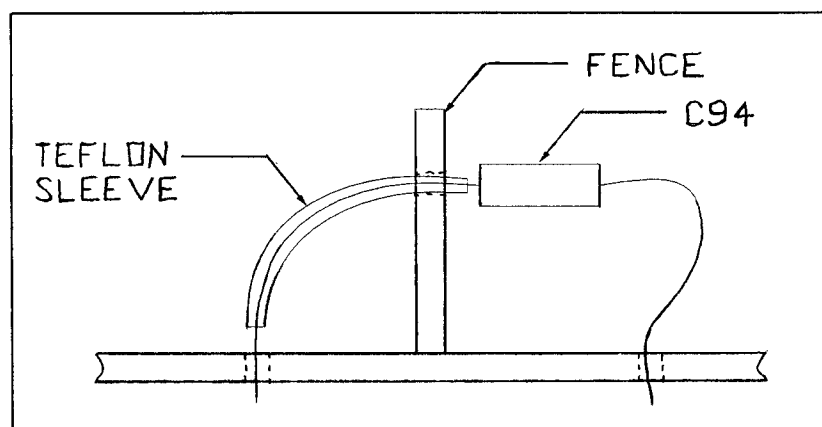
Figure 1) Installation of C94 with Teflon® sleeving through the shield fence.

- A. Remove the top cover from the transceiver.
- B. Remove the Guard Receiver Module from slot A8 per the RT-138F Maintenance Manual, Report 1325.
- C. Install capacitor, C94, PN 106-00001-0008 with Teflon® sleeving, PN 16016-22 in place of inductor L17. Refer to Figure 1 for application of sleeving.
