APPROVALS	DATE	TITLE		
DRAWN <i>Kylie Esaw</i>	5-16-02	<b>SERVICE BULLETIN, WSB C-5000-11 FIXES UNSQUELCH FOR MAIN CHANNEL RECEIVER</b>		
CHECKED <i>Clayton C. Eaton</i>	5-16-02	SIZE	CAGE CODE	DWG. NO.
ENGINEER <i>Stan Wilk</i>	5-16-02	A	1B7G3	150-041428
ISSUED <i>V. Wallace</i>	05/16/02	SCALE NONE		
				REV <b>A</b>

# SERVICE BULLETIN

**EQUIPMENT** C-5000

**BULLETIN NUMBER** WSB C-5000-11 Revision A

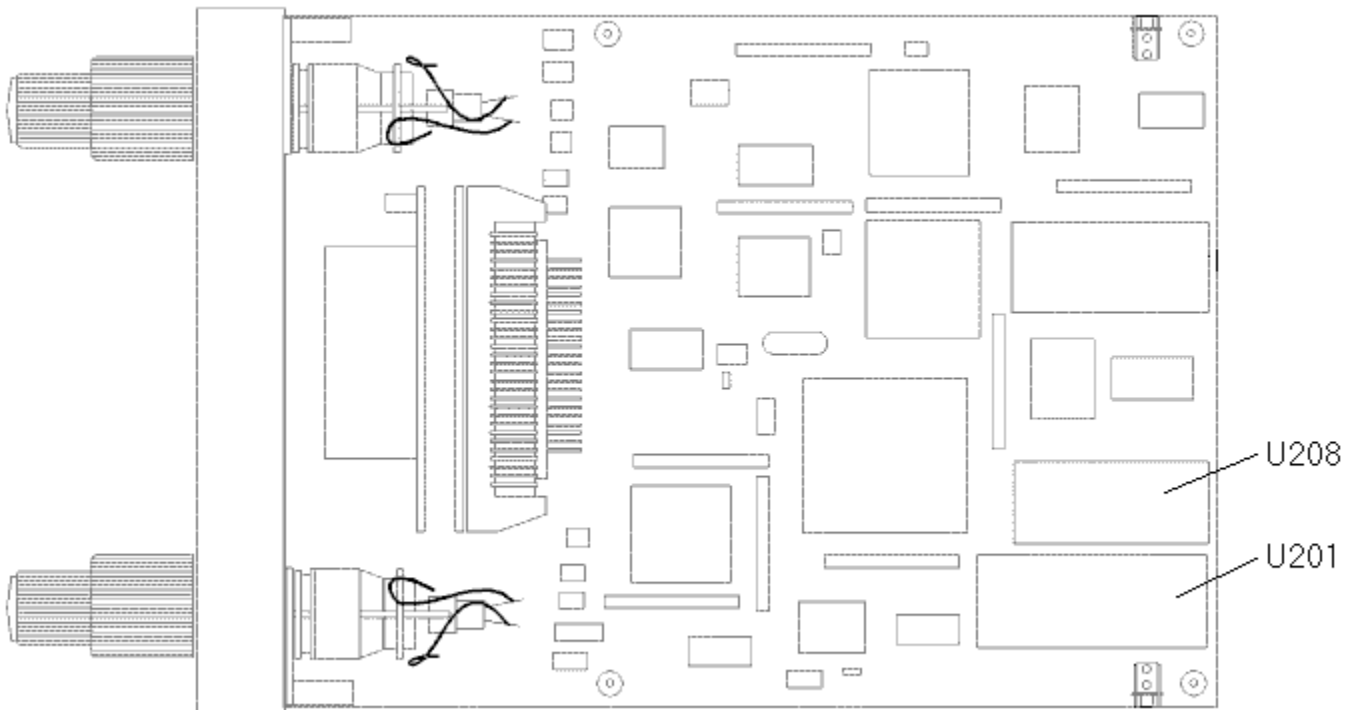
**FIGURE 1. UVPROM Locations, CPU board**

RT-5000 would not unsquelch when receiving a main channel. A variable (OTAR bits) was not being initialized properly.

1. Remove the cover from the C-5000 chassis.
2. Remove UVPROM's: U201 (P/N 106-841141-XX)  
U208 (P/N 106-841143-XX)  
from the CPU board 300-017305-01XX (see Figure 1).
3. Install updated UVPOM's: U201 (P/N 106-841141-03)  
U208 (P/N 106-841143-03)  
onto the CPU board (P/N 300-017305-01XX).
4. Reinstall the cover on the C-5000.
5. Remove existing software MOD label.
6. Mark new software MOD label (P/N 156-017926-03) with 03.
7. Affix new software MOD 03 label.
