DOCUMENT TITLE  
**SERVICE INSTRUCTION WSI DF-431B-18  
 IMPROVE MISMATCH AND  
 RADIO SENSITIVITY**

SIZE <b>A</b>	LRU <b>DF-431B</b>	DOCUMENT NUMBER <b>150-043453-18</b>	REV <b>A</b>
------------------	-----------------------	---	-----------------

**EQUIPMENT: DF-431B**

**SERVICE INSTRUCTION NUMBER: WSI DF-431B-18**

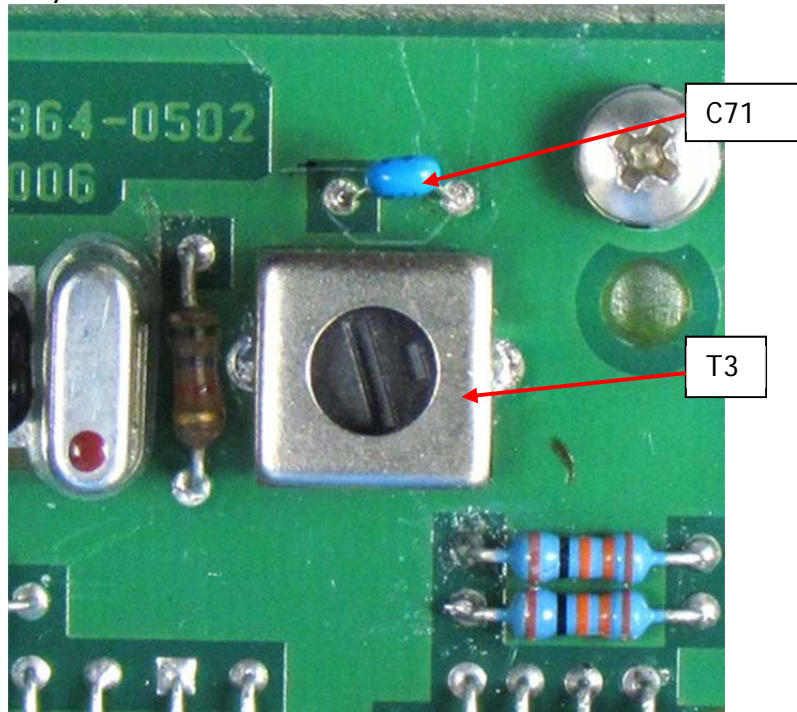
Figure 1

This WSI is only applicable to units that exhibit more than 0.5 degrees offset when changing from high field strength (1000uV/m) to lower field strength (100uV/m) AND have a transformer (T3) on the Receiver Board (200-07590-0000) that does not have "Toko" on the lid or a sticker with p/n 118-243436.

1. Remove C71 from Receiver board shown in
2. Figure 1.
3. Replace C71 with Item 1.
4. Replace or rework T3 .
  - a. Replace T3 (Option 1)
    - i. Remove T3.

- xi. Solder reworked part back into receiver board at T3 location shown in Figure 1.
