SERVICE BULLETIN

EQUIPMENT: IDU-III

BULLETIN NUMBER: WSB IDU-III-20 Revision B

MANDATORY SERVICE BULLETIN

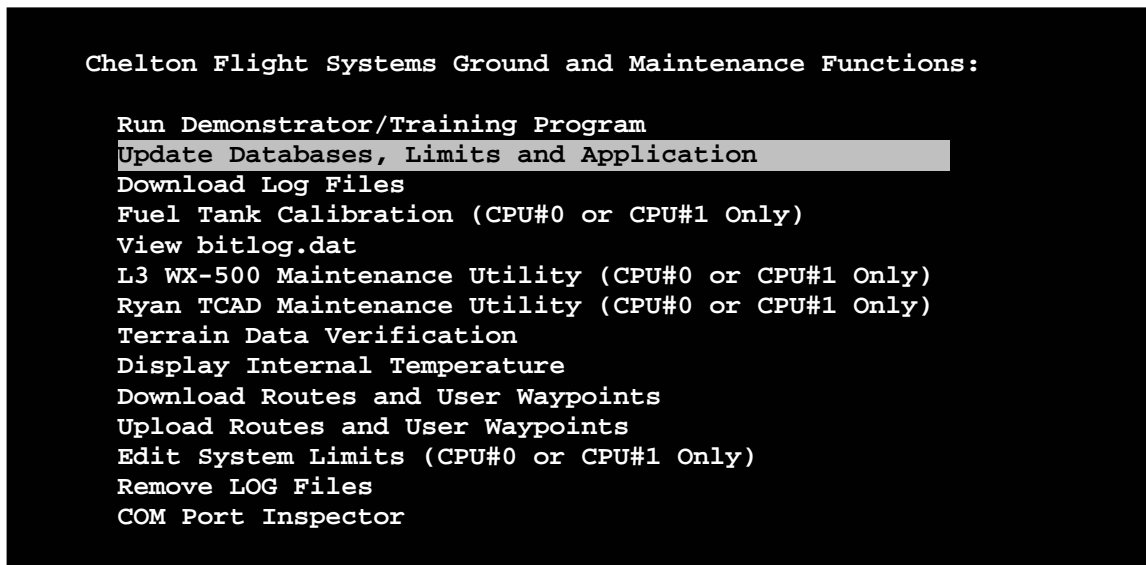
Figure 1 Ground Maintenance Menu

1. Apply external power to the aircraft.
2. Ensure power is removed from the IDU(s).
3. Insert the SmartMedia card (Item 1) from the Service Bulletin Kit into the PFD or single IDU.
4. Apply power to the IDU(s).
5. Verify the PFD or single IDU displays the Ground Maintenance menu (see Figure 1).

6. Rotate the right-hand encoder until the “Update Databases, Limits and Application” is highlighted then press in the right-hand encoder.
7. Verify the application software has been downloaded (See Figure 2 for details). This should take approximately 15 seconds to download.

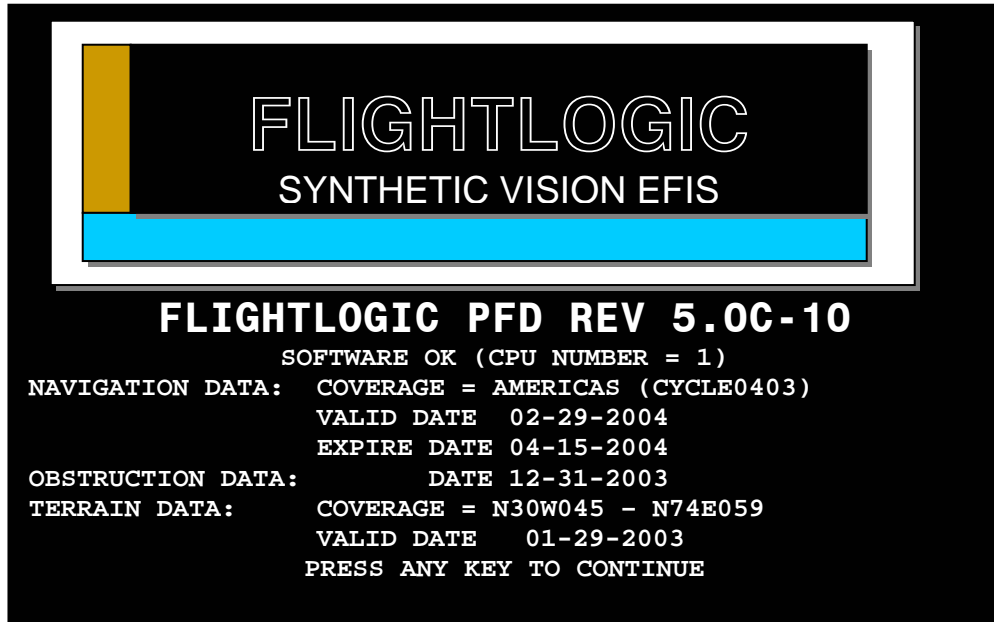
Figure 3 Typical EFIS Status Page

1. Apply power to the EFIS system and verify each IDU completes initialization and testing.
2. Verify the information listed below is displayed on each modified IDU status page (See Figure 3):
 - a. "Rev 5.0C-10"
 - b. "SOFTWARE OK"
