Wulfsberg Electronics <i>A Chelton Group Company</i>			
APPROVALS		DATE		TITLE: SERVICE BULLETIN WSB IDU-III-9 (DEPARTURE AND MISSED APPROACH PROCEDURE)	
DRAWN Robert DuRall		11/18/2003			
CHECKED Dean Boston		11/18/2003			
PRODUCT MANAGER Mark McCormack		11/18/2003			
ENGINEER		SIZE	CAGE CODE	DWG NO.	REV
ISSUED Vern Wallace		A	1B7G3	150-045973	A
Typed signatures indicate approval. Handwritten signature approval of this document is on file at Wulfsberg Electronics, Prescott, Arizona.		SCALE: NONE		DO NOT SCALE DRAWING

SERVICE BULLETIN

EQUIPMENT: IDU-III

BULLETIN NUMBER: WSB IDU-III-9 Revision A

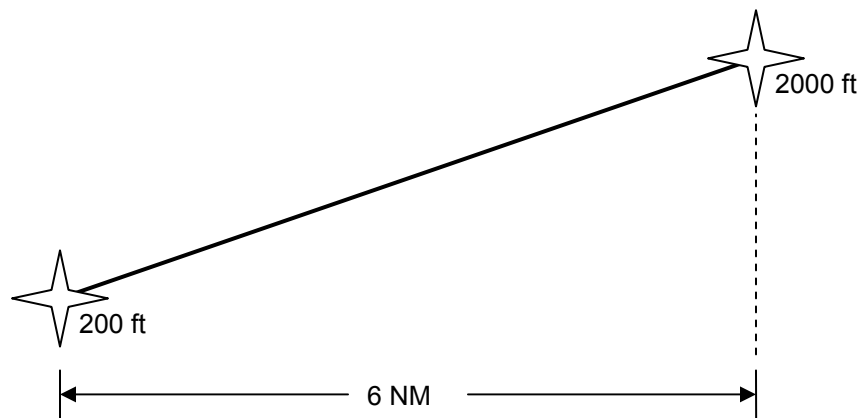
In the current software, altitude leg length is pre-computed based upon database start and end altitudes and a climb rate of 300 feet per nautical mile. The software then places a phantom fix (waypoint symbol without a name) at the calculated end of climb point that is used for navigation guidance. This methodology does not take into account the aircraft's actual climb performance. The diagram below shows how altitude leg length is computed in the current software:

$$\text{Leg Length} = (2000\text{ft} - 200\text{ft}) / 300\text{ft per NM} = 6\text{NM}$$

This methodology is safe under most circumstances because 300 feet per nautical mile exceeds the standard TERPS climb rate of 200 feet per nautical mile. However, under certain circumstances, this methodology can result in hazardously misleading guidance into non-protected areas. These circumstances are described below:

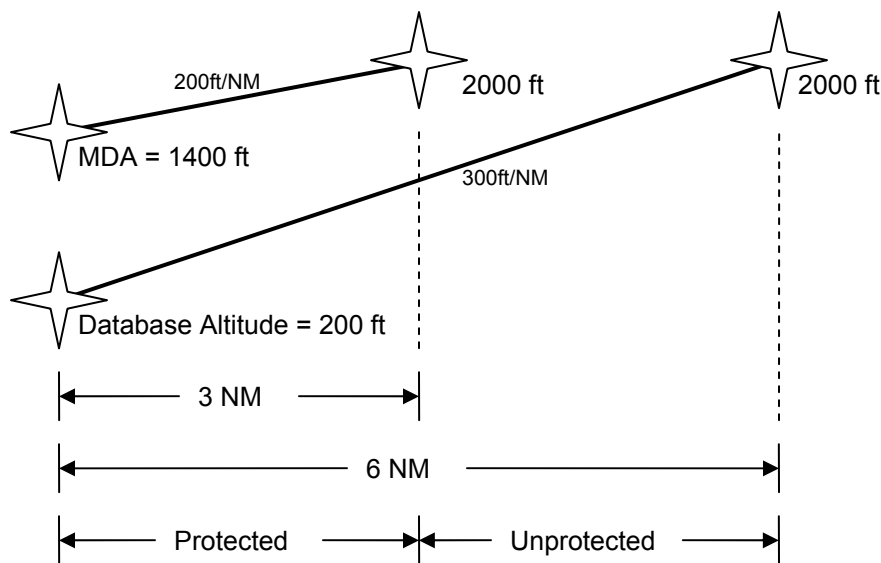
Under ARINC424 rules, whenever there are straight-in minimums for an instrument approach procedure, the database Missed Approach Point (“MAP”) altitude will be coded so as to provide a stabilized approach to the designated straight-in runway and will not reflect the MDA or DH for the approach. In the case where the database MAP altitude is lower than the MDA or DH, and the first leg of the missed approach procedure is an altitude leg, the altitude leg length calculated by the current methodology may exceed the designed protected length. This is depicted graphically below:

1. Use of the equipment to provide guidance on departure procedures that require a climb rate greater than 300 feet per nautical mile and that require a climb to an altitude before initiating a turn is prohibited.

2. Instrument approach navigation must be accomplished in accordance with the approved instrument approach procedure. Before conducting an instrument procedure, the displayed procedure must be verified by reference to current approved data. If the displayed Missed Approach Procedure is different than the written published Missed Approach Procedure, the displayed guidance is incorrect and the procedure must be flown in accordance with the written published Missed Approach Procedure. Use of the equipment to provide missed approach guidance is prohibited.

3. For Missed Approach Procedures that require a climb to an altitude before initiating a turn, use of the equipment to provide missed approach guidance is prohibited. The procedure must be flown in accordance with the written published Missed Approach Procedure.

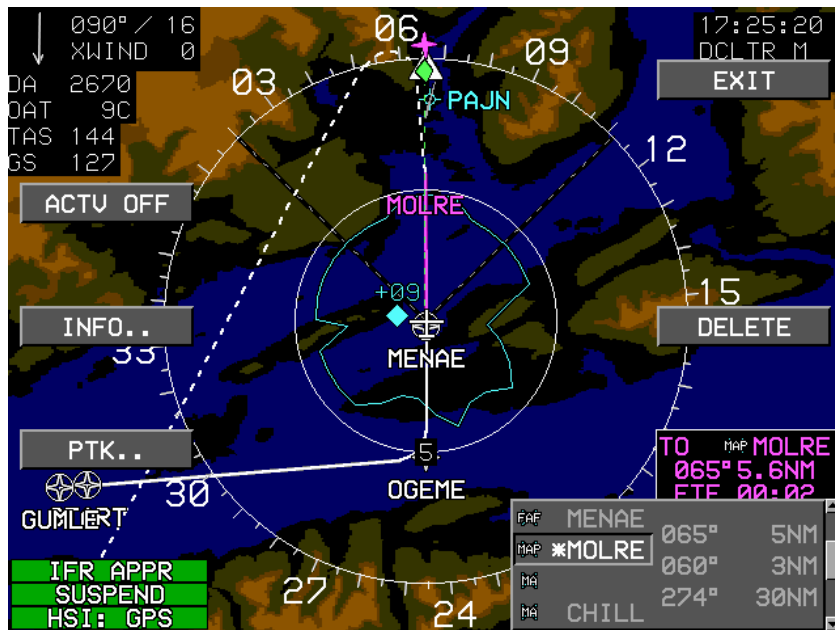
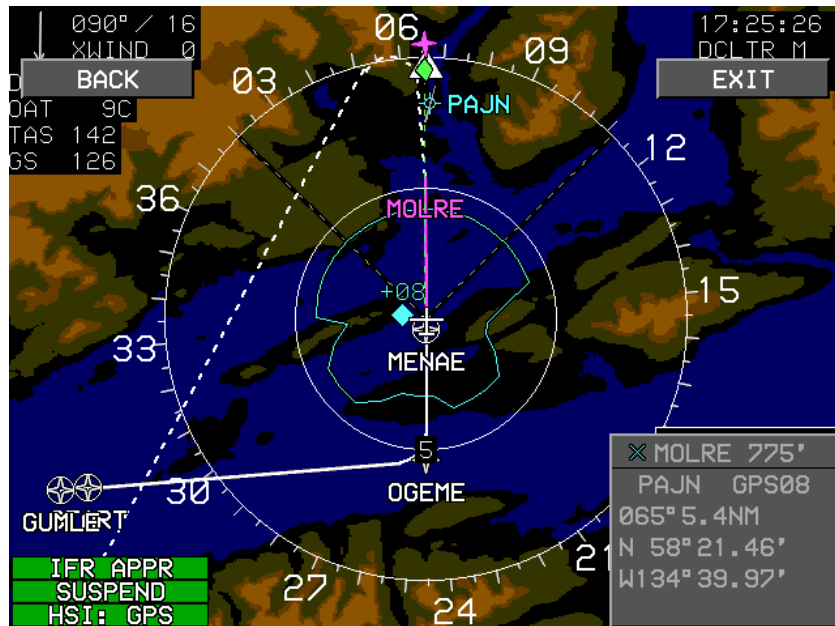
1. Review the approach plate for the procedure. If the first leg of the missed approach is an altitude leg, then there is the possibility of hazardously misleading guidance into non-protected areas.
2. Review the active flight plan waypoints using the <ACTV> button. Highlight the MAP (identified by the letters “MAP” over the waypoint symbol in the active flight plan list). Use the <INFO> option to view the database MAP altitude. In the screen captures below, the database MAP altitude (waypoint MOLRE) is displayed as 775’:

3. If the database altitude is below the MDA or DH published for the approach then, workload permitting, the following formula can be used to determine whether there is hazardously misleading guidance into non-protected areas:

4. If the guidance is hazardously misleading, the operator must ignore the guidance and fly the missed approach procedure manually by reference to the published approach plate only. It is recommended that Highway in the Sky guidance be decluttered from the PFD in this condition. The operator should also keep in mind that the terrain display function is unaffected by this condition and continues to provide situational awareness cues.
5. In all cases, the published approach plate takes precedence over the database derived approach guidance. ALWAYS comply with the published approach plate.
